IMPORTANT PRODUCT RECALL NOTICE

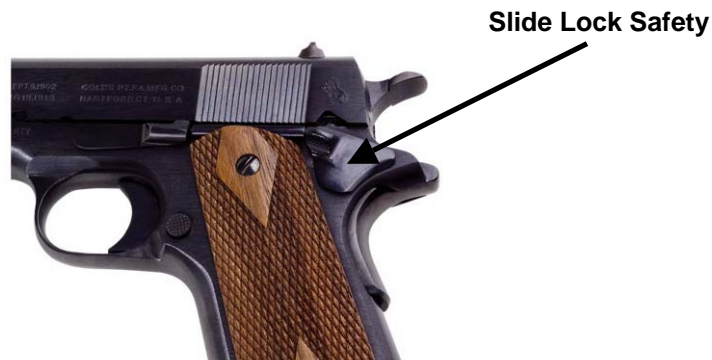
The Safety is located on the left side of the pistol just below the slide:

Colt has determined that the Safety and the Guide Pad in the affected pistols are of improper hardness. As a result, the Safety can prematurely wear or bend, especially if the pistol is dropped, possibly rendering the Safety incapable of preventing an accidental firing, and the Guide Pad might crack and possibly prevent the pistol from firing. Although there have been no reports of personal injuries or property damage, safety is our number one concern. Therefore, the affected pistols should not be loaded or used until the Safety and/or Guide Pad have been replaced.

3. We will replace the Safety (and, on NEW AGENT models only, install a new Recoil Spring Assembly Kit that includes replacement of the Outer Recoil Spring and Guide Pad) and return your firearm to you as quickly as possible.
Note: We cannot return your firearm to a P.O. Box address. Therefore, we will need your street address where the firearm will be returned.

4. **DO NOT LOAD OR USE YOUR FIREARM** until we have performed this repair.
 5. **DO NOT ATTEMPT TO MAKE THIS REPAIR YOURSELF.** The Slide Lock Safety **must** be replaced at the factory in order to be done properly.

For **1911 WWI REPLICA and 1918 WWI REPLICA** models on which the Slide Lock Safety has been replaced, our gunsmiths will stamp a small "-" on the inside right rear of the slide, directly below the extractor, as confirmation that the retrofit has been performed. For **COMBAT ELITE** models on which the Slide Lock Safety has been replaced, our gunsmiths will stamp a small pennant "☞" on the bottom right side of the trigger guard. **NEW AGENT** models on which both the Slide Lock Safety and Recoil Spring Guide Pad have been replaced will have two marks. Our gunsmiths will stamp a small pennant "☞" on the bottom right side of the trigger guard as confirmation that the Slide Lock Safety retrofit had been performed. The new Recoil Spring Guide Pad has a small dimple appearing on the top left, rear-facing, surface of the pad.

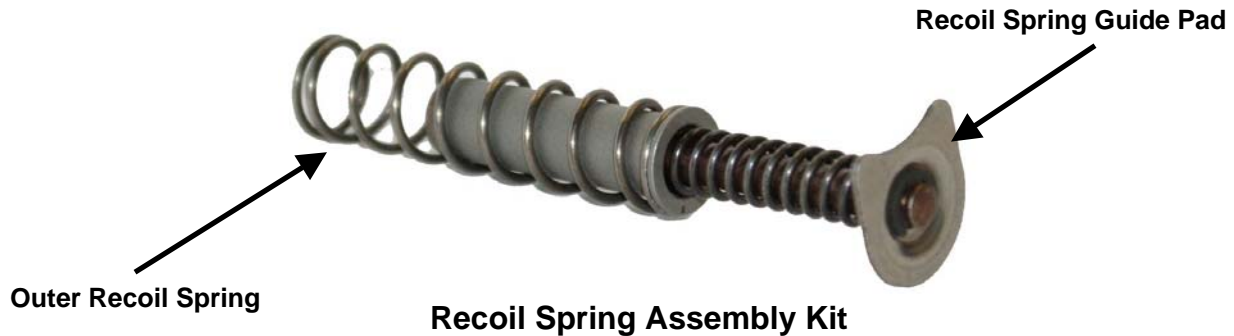
The Guide Pad is located at the end of a recoil spring assembly, which is positioned inside the slide between the recoil spring bushing and the barrel lug. On the recoil spring assembly, the Guide Pad looks like this:

You do not need to return the DEFENDER model pistols to Colt. We will provide you with a free Recoil Spring Assembly Kit and instruct you how to install it yourself. If you would like us to install the kit for you, please make this request of Colt Customer Service. In either case, please take the following steps:

Please note that, apart from this recall, we designed a symmetrical Outer Recoil Spring with closed ends on each side for the NEW AGENT and DEFENDER models. This design allows the spring to be inserted from either end into the recoil bushing. This replacement spring will be included as part of the Recoil Spring Assembly Kit being furnished in this recall. The new Recoil Spring Guide Pad has a small dimple appearing on the top left, rear facing, surface of the pad that will serve as confirmation that the retrofit has been performed.
